EXPERIMENTS TO DETERMINE DEBRIS FORMATION
FROM CORRUGATED STEEL AND BRICK WALLS

Final Report

January 1970

URS RESEARCH COMPANY

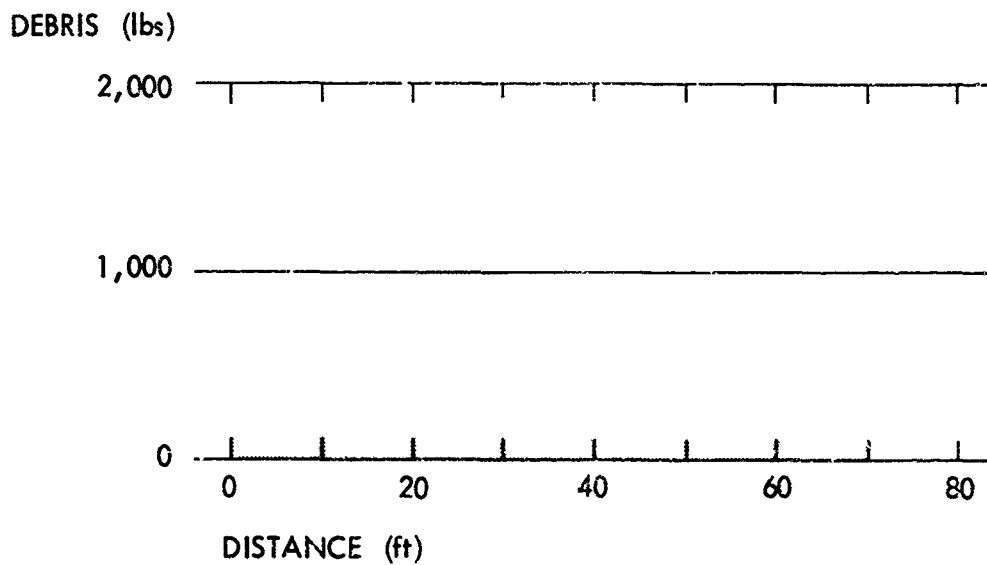
Debris Distribution, Wall Number 22

Results: Two initial horizontal cracks were noted at heights of ~3 ft and 6.5 ft. The wall failed and scattered debris to 70 ft. (See debris distribution chart below).

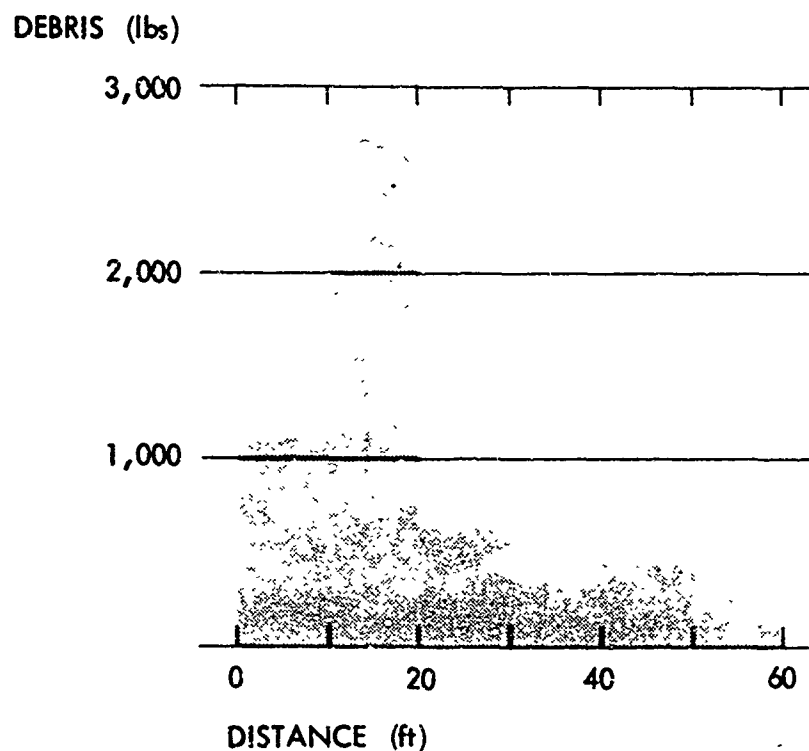
Debris Distribution, Wall Number 23

Results: Initial cracks formed as shown in sketch below. The wall failed, and debris was scattered to 57 ft. (See debris distribution chart).

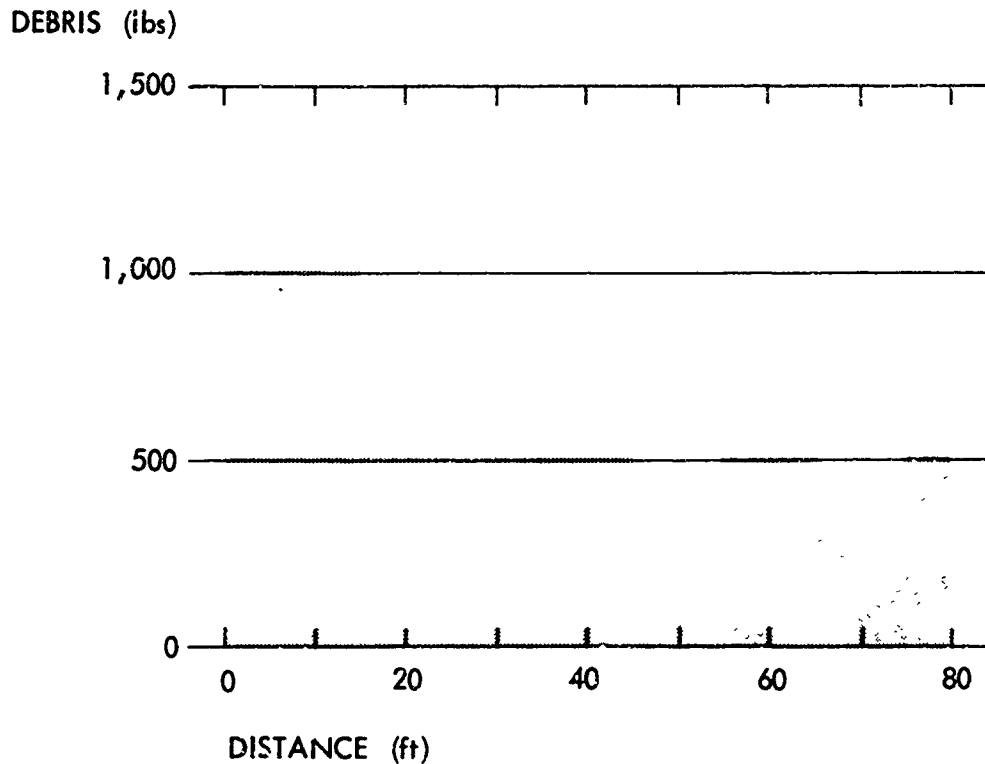
Debris Distribution, Wall Number 26

Results: The wall failed, and debris scattered to 80 ft. (See debris distribution chart below).
